NATIONAL BUREAU OF STANDARDS REPORT

Visual Landing Aids
Field Service Operation

Progress Report
For the Period
December 1, 1952 to November 30, 1953

Prepared By
C. A. Douglas
J. W. Simeroth
J. E. Davis
Photometry and Colorimetry Section
Optics and Metrology Division

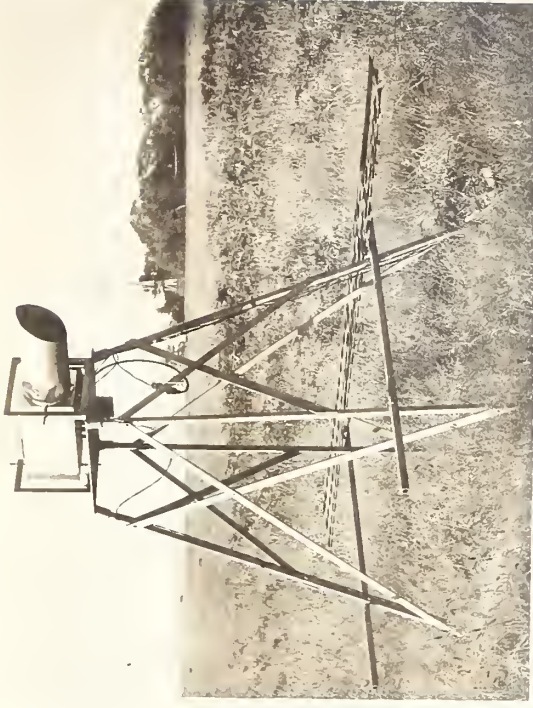
FIG. 3 EXAMPLES OF TRANSMISSOMETER INSTALLATIONS

RECEIVER

PROJECTOR

INDICATORS

Transmissometers in the approach zone and touchdown zone had been installed for operational use under the jurisdiction of the Civil Aeronautics Administration. Arrangements were made to transfer jurisdiction of these instruments to the Field Operation. In addition, one transmissometer from the Naval Air Test Center and one transmissometer and a number of spare components from the NBS laboratory in Washington were shipped to the field location. These instruments are now installed, as indicated on figure 2. These instruments provide adequate measurements of atmospheric transmission throughout the area in which visibility observations are made. Use was made of permanent and portable transmissometer stands already at the airport in making these installations. Details of some of these installations are shown in figure 3. The indicators were installed in the laboratory space in the Operations Building. Two additional automatic sensitivity controls were constructed so that the sensitivity range of all indicators can be controlled automatically. Signal lines between the field units were obtained by using existing cable runs where possible and installing lines where necessary.
